PRELIMINARY REPORT

ATF-5

Test Date: 7 December 1962

## ATF-5 REPORT

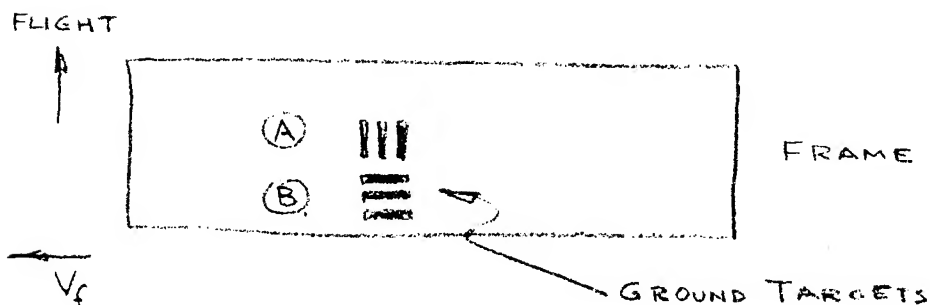
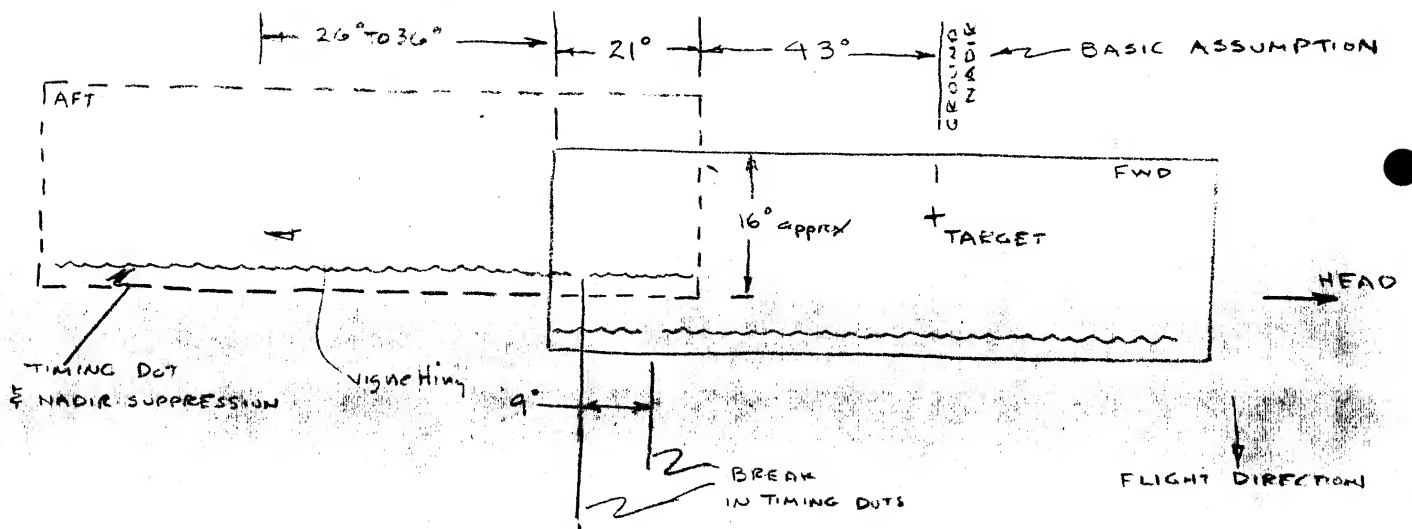
ATF-5  
SCANNER PHASING  
RUN 1

Scanners not phased properly. Forward scanner leading its correct position by  $45^{\circ}$  and aft scanner leading its correct position by  $55^{\circ}$ . This means that aft scanner was leading the forward scanner by  $10^{\circ}$  instead of  $42\frac{1}{2}^{\circ}$ . On ATF-4 the forward scanner was phased properly (to about  $\pm 3^{\circ}$ ) and the aft was misphased (leading)  $40^{\circ}$ --the same condition as LTF-17.

ANGLES IN TERMS OF  $\beta$  AT 3.25" / INCH OF FILM  
ANGLES MEASURED  $\pm 5^\circ$

FWD TO FWD OVER-LOOK = 2 INCHES OF FRAME  $\approx 3^\circ$  OF  $\alpha$

- 5.1 Rephase scanners and check IMC, capping shutter phasing.
- 5.2 Implement correction of slit relay pulse (elements relay).
- 5.3 Check V/h sensor grid frequency, focus, wiring from interface package to system and test signal wiring.
- 5.4 Locate break in LVSYN test signal lead and correct.
- 5.5 Do not short cut ground check-out with Brush recorder.
- 5.6 Replace Natel Master Oscillator (spare available December 14th).
- 5.7 Institute search for cause of static (or pressure) marks.
- 5.8 Recommend fly same test again, after corrections.
